**Flood Control Project Maintenance
Levee Inspections**

Maintenance Issue Types Only, Levee Inspection Report By Mile - Spring 2019

Sacramento Maintenance Yard Willow Slough Bypass

Waterway	Bank	Unit Miles	Inspection Start/End	Inspector
Unit No. 01 Willow Slough Bypass or North Levee	Left	5.05	04/30/2019 04/30/2019	Zach Jojola

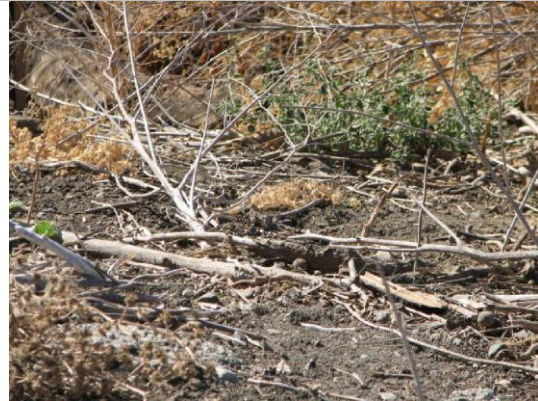
Photo 2 of 3 : UCIP_SP_2019_44903_22881.jpg

FS_ID:44903
 DS_ID:17834
 EP_NO: 10130
 Repair Type: No Action Needed
 Crossing Status: Found
 UCIP Comments: 01/08/2019 Received updated permit information for this crossing from D. Biswas with the CVFPB. The structure description has been updated with the correct abandonment permit information. (O. Magana - DWR UCIP)
 05/02/2017 CVFPB Letter sent April 12, 2012 regarding Permit #10130 - Internal Inspections of Pipes Crossing State Plan of Flood Control Levee. Permit No. 10130 previously referenced in UCIP record was removed--permit does not reference 36-inch pipe. (O. Magana - DWR UCIP)
 04/12/2017 Mud/debris on WS removed by JK, RF. (C. Lund - DWR Sacramento Yard)
 05/05/2015 Removed debris from the outlet. (C. Lund - DWR Sacramento Yard)
 09/19/2012 Minor debris blocking flap gate. Debris/log needs to be removed from the outlet. (P. Amatya - DWR UCIP)
 FIELD_STRUCT_DESC: 36-inch corrugated metal drainage pipe through the levee, 18 feet below the crown. Flap gate is located on the waterside (WS) end. (no permit was found authorizing 36-inch pipe [pipe is referenced in O&M Manual, Station 271+54]; 36-inch was authorized for abandonment under Permit No. 12789-1, 2018 - City of Davis) [Additional Reference(s): USACE Sacramento O&M Manual Unit 120, Willow Slough Channel Relocation and Levee Construction, February 1947, Drawing No. 50-4-2281 Sheet 4 (Station 271+54)]

Waterside view- general view

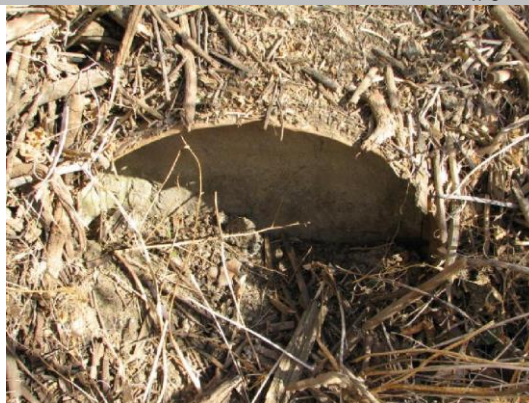
Photo 1 of 3 : UCIP_SP_2019_44904_22885.jpg

Comment Code					
Inspector Comment					
FS_ID:44904 DS_ID:17613 EP_NO: 10309 Repair Type: No Action Needed Crossing Status: Found UCIP Comments: 09/19/2012 Abandoned in place. CMP filled with concrete. (DWR UCIP - P. Amatya) FIELD_STRUCT_DESC: 30-inch steel drainage pipe through the levee, 16.5 feet below the crown. Flap gate is located on the waterside (WS) end. Manhole and grate are located on the landside (LS) toe. (30-inch pipe [HLM 0.01] authorized under Automatic Board Order (ABO) issued as Permit No. 10309, 1974 - City of Davis). [Additional Reference(s): DWR Levee Log, 1990. USACE Sacramento O&M Manual Unit 120, Willow Slough Channel Relocation and Levee Construction, February 1947, Drawing No. 50-4-2281 Sheet 4 (Station 270+70)] FS Date: 5/5/2015 8:02:49 AM

Waterside view- CMP grouted with concrete.

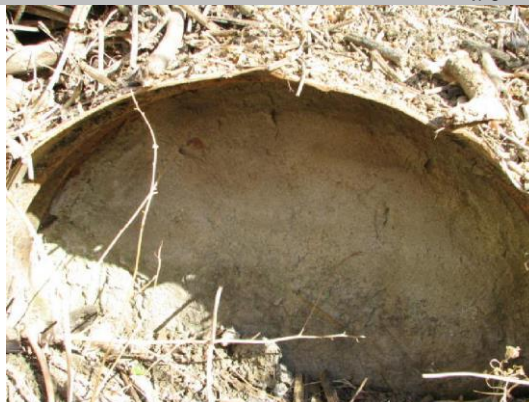
Photo 2 of 3 : UCIP_SP_2019_44904_22884.jpg

Waterside view- CMP grouted with concrete (closer view)

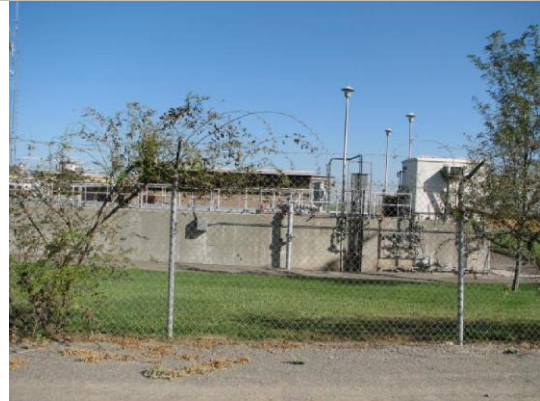
Photo 3 of 3 : UCIP_SP_2019_44904_22886.jpg

Landside overview- pumping plant not related with this crossing.

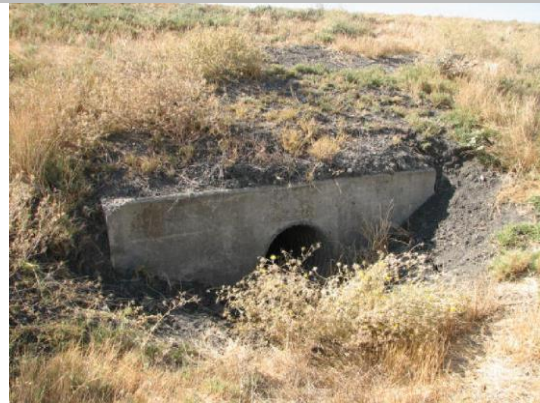
Photo 1 of 3 : UCIP_SP_2019_44907_22894.jpg

Comment Code					
Inspector Comment					
FS_ID:44907 DS_ID:17608 EP_NO: 10313 Repair Type: No Action Needed Crossing Status: Found UCIP Comments: 04/12/2017 LS - dump has it plugged, WS - ditch need to be established debris higher than water, inspected by JK, RF. (DWR Sacramento Yard - C. Lund) 09/19/2012 Pipe sits on concrete saddle on WS. (DWR UCIP - P. Amatya) FIELD_STRUCT_DESC: 24-inch corrugated metal drainage pipe through the levee, 13.5 feet below the crown. Flap gate is located on the waterside (WS) end. (24-inch pipe [HLM 0.79] authorized under Automatic Board Order (ABO) issued as Permit No. 10313, 1974 - Lear). [Additional Reference(s): DWR Levee Log, 1990. USACE Sacramento O&M Manual Unit 120, Willow Slough Channel Relocation and Levee Construction, February 1947, Drawing No. 50-4-2281 Sheet 2, 4 (Station 232+43)] FS Date: 5/5/2015 8:06:14 AM

Landside view- pipe and headwall

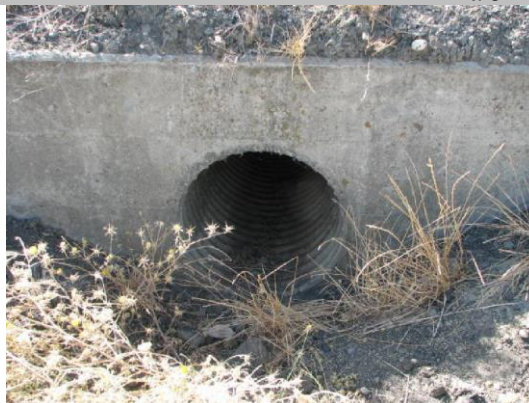
Photo 2 of 3 : UCIP_SP_2019_44907_22893.jpg

Comment Code						
Inspector Comment						
FS_ID:44907 DS_ID:17608 EP_NO: 10313 Repair Type: No Action Needed Crossing Status: Found UCIP Comments: 04/12/2017 LS - dump has it plugged, WS - ditch need to be established debris higher than water, inspected by JK, RF. (DWR Sacramento Yard - C. Lund) 09/19/2012 Pipe sits on concrete saddle on WS. (DWR UCIP - P. Amatya) FIELD_STRUCT_DESC: 24-inch corrugated metal drainage pipe through the levee, 13.5 feet below the crown. Flap gate is located on the waterside (WS) end. (24-inch pipe [HLM 0.79] authorized under Automatic Board Order (ABO) issued as Permit No. 10313, 1974 - Lear). [Additional Reference(s): DWR Levee Log, 1990. USACE Sacramento O&M Manual Unit 120, Willow Slough Channel Relocation and Levee Construction, February 1947, Drawing No. 50-4-2281 Sheet 2, 4 (Station 232+43)] FS Date: 5/5/2015 8:06:14 AM

Landside view- pipe and headwall closer view

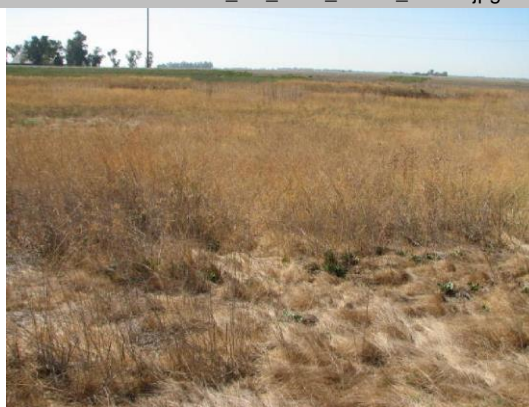
Photo 3 of 3 : UCIP_SP_2019_44907_22892.jpg

Waterside view

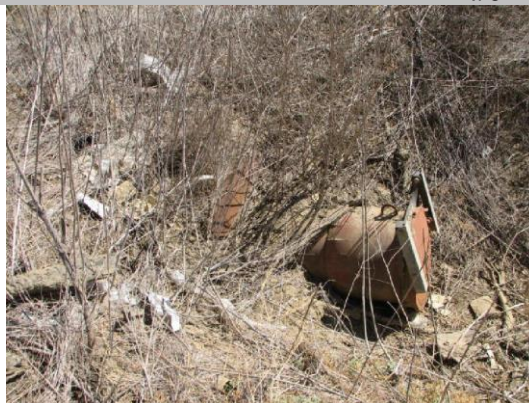
Photo 1 of 3 : UCIP_SP_2019_44929_22929.jpg

Comment Code					
Inspector Comment					
FS_ID:44929 DS_ID:17623 EP_NO: 10310 Repair Type: No Action Needed Crossing Status: Found UCIP Comments: FIELD_STRUCT_DESC: 20-inch steel drainage pipe sleeved though 30-inch corrugated metal pipe through the levee, 12.5 feet below the crown. 24-inch flap gate is located on the waterside (WS) end. (30-inch pipe [HLM 1.53] authorized under Automatic Board Order (ABO) issued as Permit No. 10310, 1974 - Hunt-Wesson Foods, Inc.) [Additional Reference(s): DWR Levee Log, 1990. USACE Sacramento O&M Manual Unit 120, Willow Slough Channel Relocation and Levee Construction, February 1947, Drawing No. 50-4-2281 Sheet 2 (Station 192+88)] FS Date: 5/5/2015 8:20:02 AM

Waterside view- pipe and flap gate

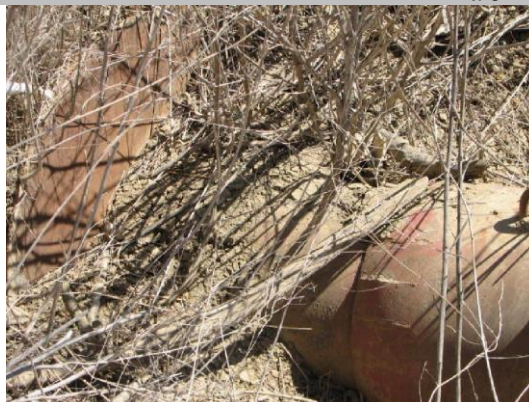
Photo 2 of 3 : UCIP_SP_2019_44929_22928.jpg

Waterside view- 20-inch pipe sleeved into 30-inch pipe

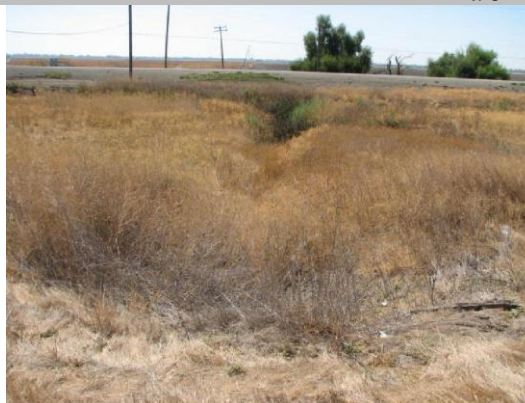
Photo 3 of 3 : UCIP_SP_2019_44929_22931.jpg

Waterside overview

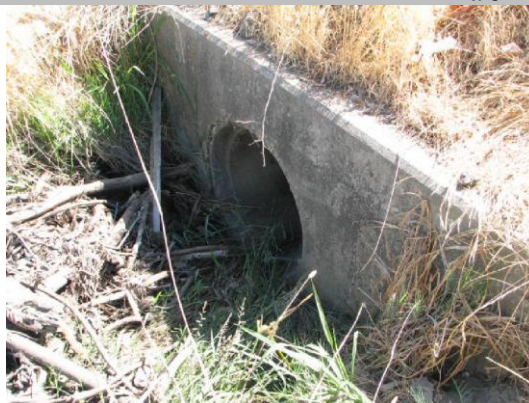
Photo 1 of 3 : UCIP_SP_2019_44937_22951.jpg

Comment Code					
Inspector Comment					
FS_ID:44937 DS_ID:17619 EP_NO: 10307 Repair Type: No Action Needed Crossing Status: Found UCIP Comments: 04/26/2017 LS - removed debris and needs to be sprayed, work completed by JK, MH. (DWR Sacramento Yard - C. Lund) 04/12/2017 LS - good/clear, WS - little debris (handwork-cleared) , inspected by JK, RF. (DWR Sacramento Yard - C. Lund) 05/28/2013 flap gate cleaned and standpipe repaired. (DWR Sacramento Yard - C. Lund) 09/19/2012 The 48-inch concrete manhole damaged - top ring knocked off in waterside. Debris found in waterside pipe. (DWR UCIP - P. Amatya) FIELD_STRUCT_DESC: 24-inch drainage pipe of unknown material through the levee, 10 feet below the crown. Flap gate is located on the waterside (WS) end. Concrete headwall is located on the WS and landside (LS) ends. Slide gate is located inside a 48-inch manhole located on the WS slope. (24-inch pipe [HLM 2.04] authorized under Automatic Board Order (ABO) issued as Permit No. 10307, 1974 - Beckman). [Additional Reference(s): DWR Levee Log, 1990. USACE Sacramento O&M Manual Unit 120, Willow Slough Channel Relocation and Levee Construction, February 1947, Drawing No. 50-4-2281 Sheet 2 (Station 165+69)] FS Date: 5/5/2015 8:25:25 AM

Landside view- concrete pipe and headwall.

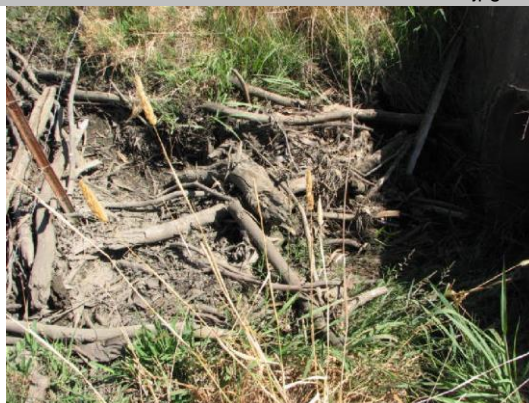
Photo 2 of 3 : UCIP_SP_2019_44937_22949.jpg

Landside view- debris

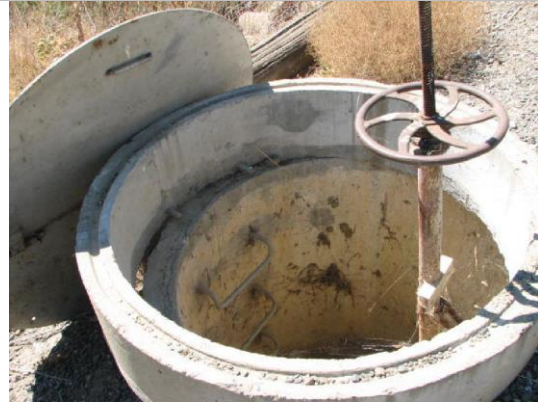
Photo 3 of 3 : UCIP_SP_2019_44937_22948.jpg

Waterside view- concrete manhole.

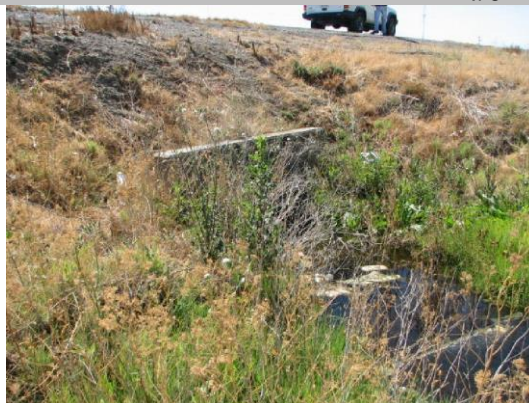
Photo 1 of 3 : UCIP_SP_2019_53861_22962.jpg

Comment Code					
Inspector Comment					
FS_ID:53861 DS_ID:17620 EP_NO: 10311 Repair Type: Urgent Crossing Status: Found UCIP Comments: 04/09/2019 Grouted 10-foot into the pipe on the WS. Internal inspection has been completed and it shows major erosion of pipe. Recommend complete removal and replacement. Pipe is in a section of major county road (Road 29). (J. McCabe - DWR Sacramento Yard)04/12/2017 good/clear on LS & WS, inspected by JK, RF. (DWR Sacramento Yard - C. Lund) 05/28/2013 Some small vegetation removal is needed on landside of the levee. (DWR Sacramento - C. Lund) 09/19/2012 Vegetation removal on landside of the levee. (DWR UCIP - P. Amatya) FIELD_STRUCT_DESC: 24-inch corrugated metal drainage pipe through the levee, 10 feet below the crown. Flap gate is located on the waterside (WS) end. (24-inch pipe [HLM 2.95] authorized under Automatic Board Order (ABO) issued as Permit No. 10311 - Ittner and Harlan). [Additional Reference(s): DWR Levee Log, 1990. USACE Sacramento O&M Manual Unit 120, Willow Slough Channel Relocation and Levee Construction, February 1947, Drawing No. 50-4-2281 Sheet 1 (Station 118+00)] FS Date: 4/9/2019 8:21:00 AM

Landside view- inlet structure

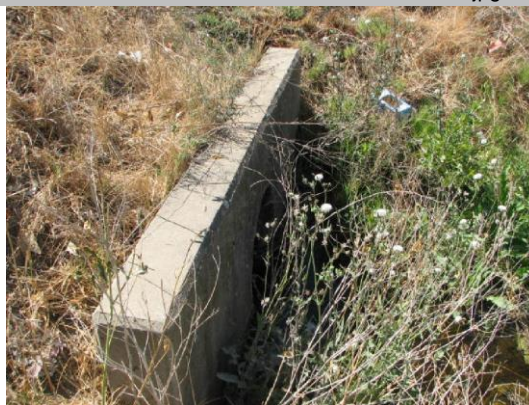
Photo 2 of 3 : UCIP_SP_2019_53861_22961.jpg

Landside view- concrete headwall

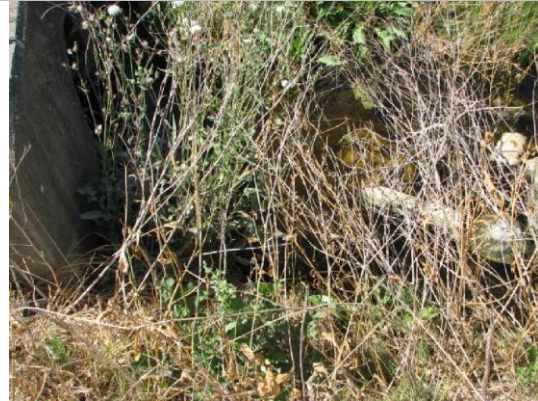
Photo 3 of 3 : UCIP_SP_2019_53861_22960.jpg

Comment Code						
Inspector Comment						
FS_ID:53861 DS_ID:17620 EP_NO: 10311 Repair Type: Urgent Crossing Status: Found UCIP Comments: 04/09/2019 Grouted 10-foot into the pipe on the WS. Internal inspection has been completed and it shows major erosion of pipe. Recommend complete removal and replacement. Pipe is in a section of major county road (Road 29). (J. McCabe - DWR Sacramento Yard)04/12/2017 good/clear on LS & WS, inspected by JK, RF. (DWR Sacramento Yard - C. Lund) 05/28/2013 Some small vegetation removal is needed on landside of the levee. (DWR Sacramento - C. Lund) 09/19/2012 Vegetation removal on landside of the levee. (DWR UCIP - P. Amatya) FIELD_STRUCT_DESC: 24-inch corrugated metal drainage pipe through the levee, 10 feet below the crown. Flap gate is located on the waterside (WS) end. (24-inch pipe [HLM 2.95] authorized under Automatic Board Order (ABO) issued as Permit No. 10311 - Ittner and Harlan). [Additional Reference(s): DWR Levee Log, 1990. USACE Sacramento O&M Manual Unit 120, Willow Slough Channel Relocation and Levee Construction, February 1947, Drawing No. 50-4-2281 Sheet 1 (Station 118+00)] FS Date: 4/9/2019 8:21:00 AM

Landside view- vegetation around inlet.

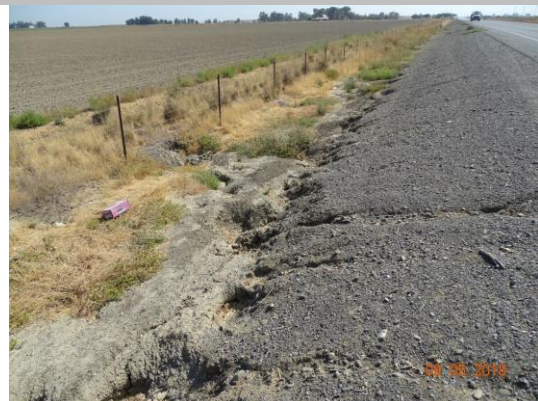
Photo 1 of 3 : SP_2019_ST0012_295_10_20190304_00002.jpg

LM Start	2.93	Rating **	M	Issue No.	10
LM End	3.00	Issue Type +	Ma	Location *	LS
Category	Earthen Levee			GPS Latitude/Longitude	
				Start	End
Item	Erosion / Bank Caving			38.590572 °	38.590653 °
				-121.719349 °	-121.720714 °
DWR ID	DWR_ST0012_01_s_2015_10				
Comment Code					
E1 : Note and monitor erosion site.					
Inspector Comment					
There appears to be runoff on the landside slope. It possibly could be from an abandoned pipeline that is caving in.

Updated view of the erosion on the landside slope. Fall 2018.

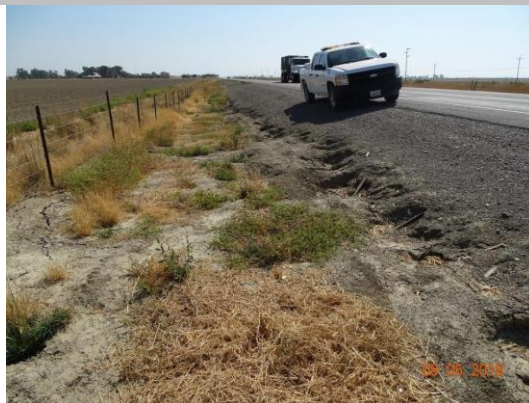
Photo 2 of 3 : SP_2019_ST0012_295_10_20190304_00003.jpg

Additional view of the erosion on the landside slope. Fall 2018.

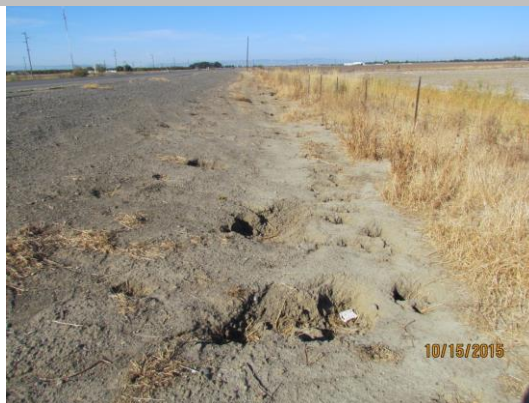
Photo 3 of 3 : SP_2019_ST0012_295_10_20190304_00004.jpg

View of the erosion on the landward side of the levee looking upstream. Fall 2015.

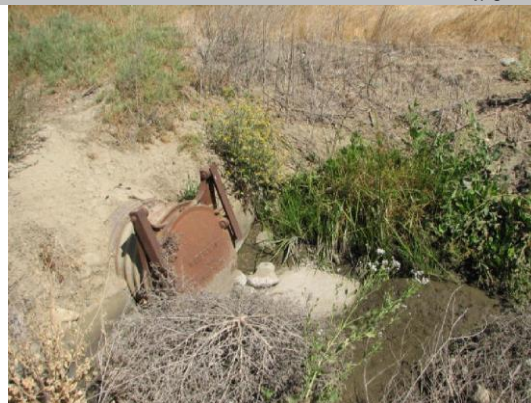
Photo 1 of 3 : UCIP_SP_2019_53862_22967.jpg

Comment Code					
Inspector Comment					
FS_ID:53862 DS_ID:17621 EP_NO: 10312 Repair Type: Urgent Crossing Status: Found UCIP Comments: 04/09/2019 Internal inspection has been completed and inspection shows major erosion on the WS outlet. Recommend complete removal and replacement. Pipe is in a section of major county road (Road 29). (J. McCabe - DWR Sacramento Yard) 04/12/2017 good/clear on LS & WS, inspected by JK, RF. (DWR Sacramento Yard - C. Lund) 09/19/2012 Depressions on waterside slope of the levee. (DWR UCIP - P. Amatya) FIELD_STRUCT_DESC: 24-inch corrugated metal drainage pipe through the levee, 10 feet below the crown. Flap gate is located on the waterside (WS) end. (24-inch pipe [HLM 3.08] authorized under Automatic Board Order (ABO) issued as Permit No. 10312, 1974 - Kelly). [Additional Reference(s): DWR Levee Log, 1990. USACE Sacramento O&M Manual Unit 120, Willow Slough Channel Relocation and Levee Construction, February 1947, Drawing No. 50-4-2281 Sheet 1 (Station 110+97)] FS Date: 4/9/2019 8:27:00 AM

Waterside view- pipe and flap gate.

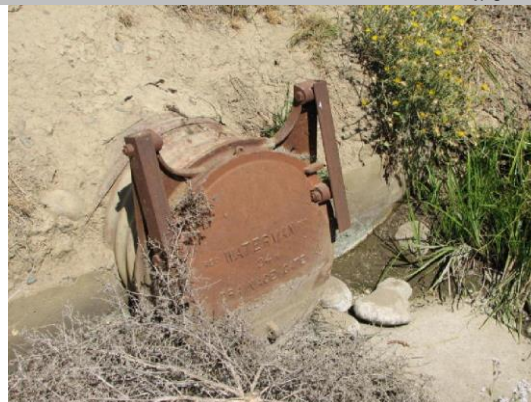
Photo 2 of 3 : UCIP_SP_2019_53862_22970.jpg

Waterside view- pipe and flap gate (close view).

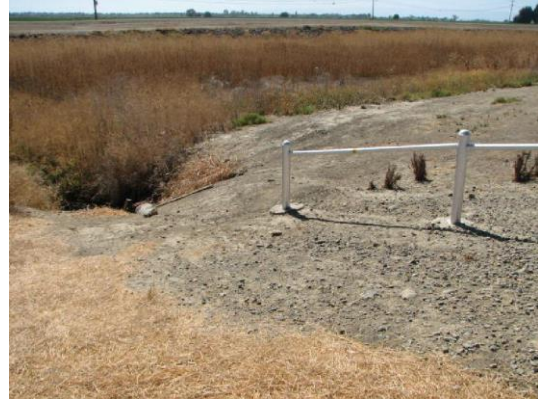
Photo 1 of 3 : UCIP_SP_2019_44947_22984.jpg

Waterside view- overview

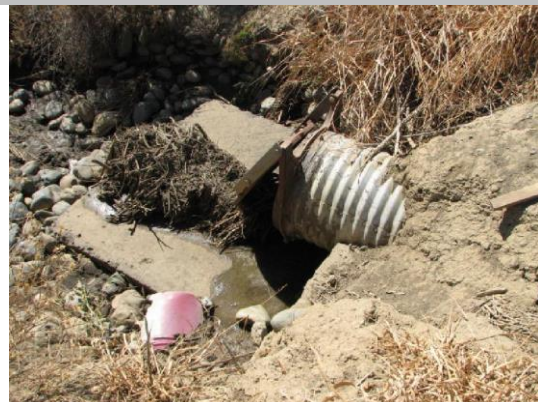
Photo 2 of 3 : UCIP_SP_2019_44947_22983.jpg

Comment Code						
Inspector Comment						
FS_ID:44947 DS_ID:17622 EP_NO: 10316 Repair Type: No Action Needed Crossing Status: Found UCIP Comments: 04/12/2017 good/clear on LS & WS, inspected by JK, RF. (DWR Sacramento Yard - C. Lund) 05/28/2013 Debris on waterside flap gate has been removed. (DWR Sacramento Yard - C. Lund) 09/19/2012 Debris on waterside flap gate. Needs debris removal from the pipe. (DWR UCIP - P. Amatya) FIELD_STRUCT_DESC: 24-inch corrugated metal drainage pipe through the levee, 11 feet below the crown. Flap gate is located on the waterside (WS) end. Concrete pad is located on the WS. (24-inch pipe [HLM 3.57] authorized under Automatic Board Order (ABO) issued as Permit No. 10316, 1974 - Stafford). [Additional Reference(s): DWR Levee Log, 1990. USACE Sacramento O&M Manual Unit 120, Willow Slough Channel Relocation and Levee Construction, February 1947, Drawing No. 50-4-2281 Sheet 1 (Station 85+00)] FS Date: 5/5/2015 8:38:32 AM

Waterside view- pipe, flap gate and debris.

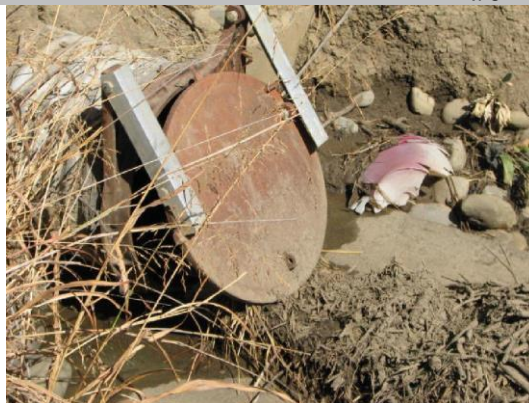
Photo 3 of 3 : UCIP_SP_2019_44947_22986.jpg

Comment Code						
Inspector Comment						
FS_ID:44947						
DS_ID:17622						
EP_NO: 10316						
Repair Type: No Action Needed						
Crossing Status: Found						
UCIP Comments: 04/12/2017 good/clear on LS & WS, inspected by JK, RF. (DWR Sacramento Yard - C. Lund)						
05/28/2013 Debris on waterside flap gate has been removed. (DWR Sacramento Yard - C. Lund)						
09/19/2012 Debris on waterside flap gate. Needs debris removal from the pipe. (DWR UCIP - P. Amatya)						
FIELD_STRUCT_DESC: 24-inch corrugated metal drainage pipe through the levee, 11 feet below the crown. Flap gate is located on the waterside (WS) end. Concrete pad is located on the WS. (24-inch pipe [HLM 3.57] authorized under Automatic Board Order (ABO) issued as Permit No. 10316, 1974 - Stafford). [Additional Reference(s): DWR Levee Log, 1990. USACE Sacramento O&M Manual Unit 120, Willow Slough Channel Relocation and Levee Construction, February 1947, Drawing No. 50-4-2281 Sheet 1 (Station 85+00)]

Waterside view- pipe, flap gate and debris. The pipe sits on concrete saddle.

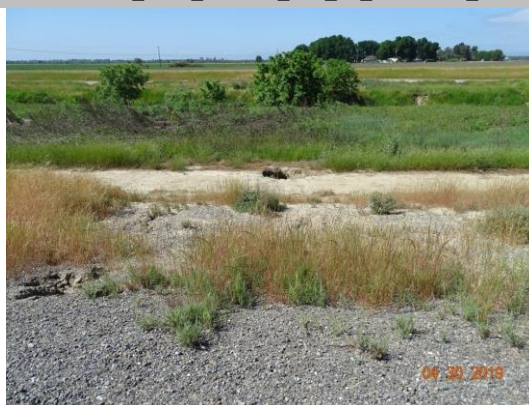
Photo 1 of 1 : SP_2019_ST0012_295_23_20190430_00031.jpg

LM Start	3.69	Rating **	A/W	Issue No.	23
LM End	3.69	Issue Type +	Ma	Location *	WS
Category	Earthen Levee			GPS Latitude/Longitude	
				Start	End
Item	Animal Control			38.591699 °	38.591699 °
				-121.733066 °	-121.733066 °
DWR ID	DWR_ST0012_01_s_2019_23				
Comment Code					
A3 : No rodents visible, but rodent burrows visible; need to backfill and compact or grout burrows.					
Inspector Comment					
There is a possible beaver den on the waterside toe road. It is not in the levee prism. Recommend monitoring for activity.

View of hole on the toe road. Spring 2019.

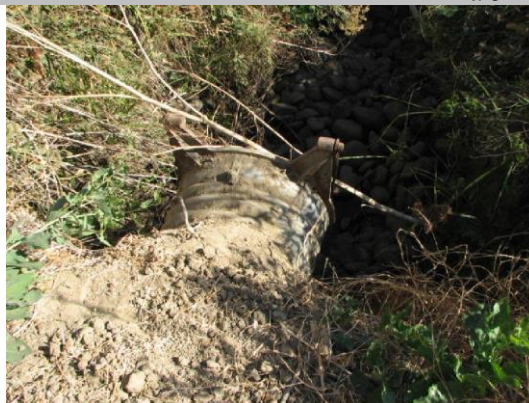
Photo 3 of 3 : UCIP_SP_2019_45286_22461.jpg

Waterside view- CM pipe and flap gate.

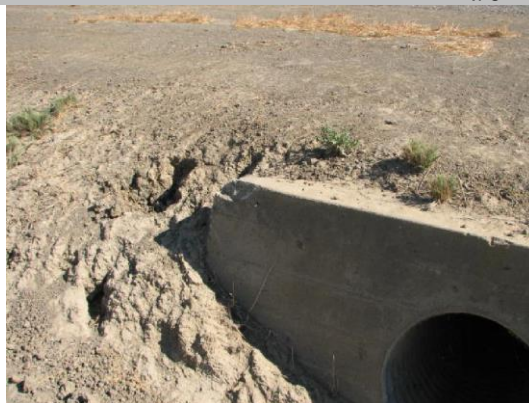
Photo 3 of 3 : UCIP_SP_2019_13725_22468.jpg

Landside view- concrete headwall corner chipped off

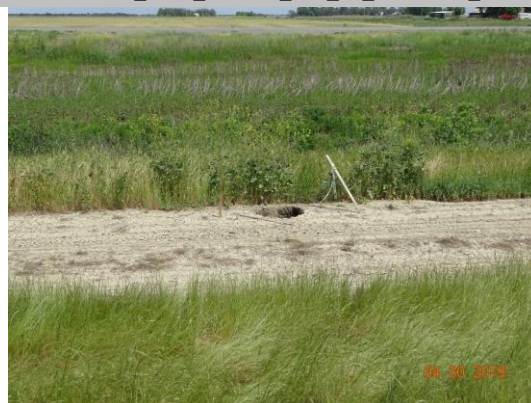
Photo 1 of 1 : SP_2019_ST0012_296_28_20190430_00055.jpg

LM Start	2.44	Rating **	A/W	Issue No.	28
LM End	2.44	Issue Type +	Ma	Location *	WS
Category	Earthen Levee			GPS Latitude/Longitude	
				Start	End
Item	Erosion / Bank Caving			38.589744 °	38.589744 °
				-121.714807 °	-121.714807 °
DWR ID	DWR_ST0012_02_s _ 2019_28				
Comment Code					
E1 : Note and monitor erosion site.					
Inspector Comment					
Runoff on the waterside toe road is causing erosion. Recommend monitoring.

View of erosion on the waterside toe road. Spring 2019.

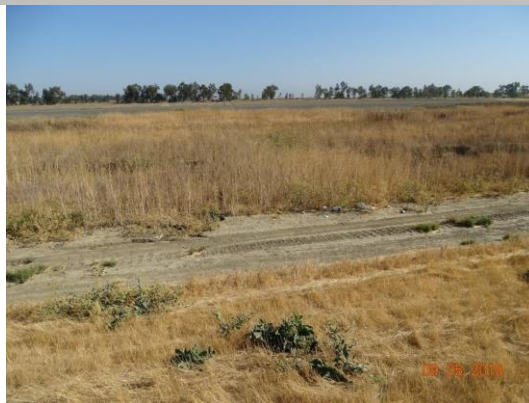
Photo 1 of 2 : SP_2019_ST0012_296_10_20190304_00004.jpg

LM Start	2.82	Rating **	A/W	Issue No.	10
LM End	2.82	Issue Type +	Ma	Location *	WS
Category	Earthen Levee			GPS Latitude/Longitude	
				Start	End
Item	Erosion / Bank Caving			38.589691 °	38.589691 °
				-121.707740 °	-121.707740 °
DWR ID	DWR_ST0012_02_f_2014_10				
Comment Code					
E1 : Note and monitor erosion site.					
Inspector Comment					
There is erosion on the waterside toe road. Recommend monitoring.

View of erosion on the waterside toe road. Fall 2018.

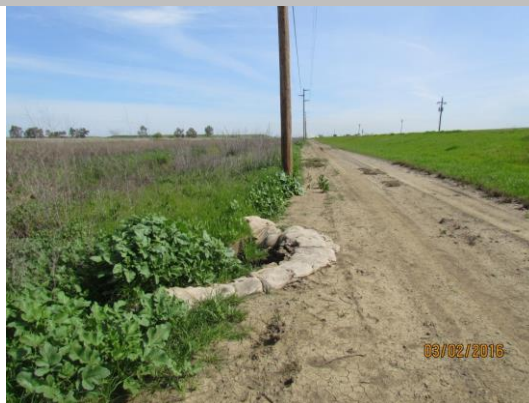
Photo 2 of 2 : SP_2019_ST0012_296_10_20190304_00005.jpg

View of the erosion on the toe road looking downstream. Spring 2016.

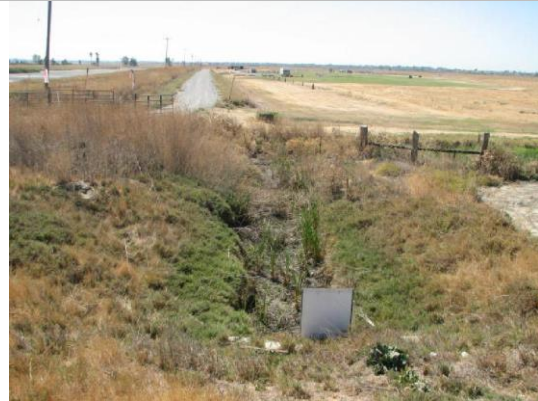
Photo 3 of 3 : UCIP_SP_2019_45291_22477.jpg

Landside view- open ditch.

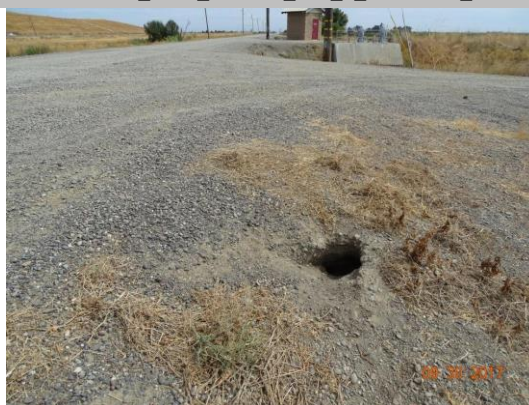
Photo 1 of 1 : SP_2019_ST0012_296_6_20190304_00001.jpg

View of burrow hole near access ramp on landside. Fall 2017.

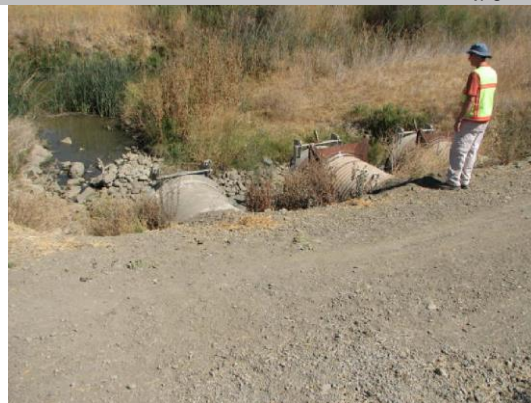
Photo 1 of 3 : UCIP_SP_2019_45294_22789.jpg

Waterside overview- middle 42-inch pipe.

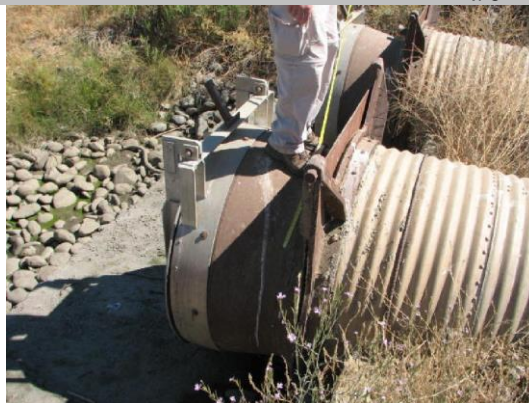
Photo 3 of 3 : UCIP_SP_2019_45294_22792.jpg

Waterside view- 42-inch steel pipe and flap gate.

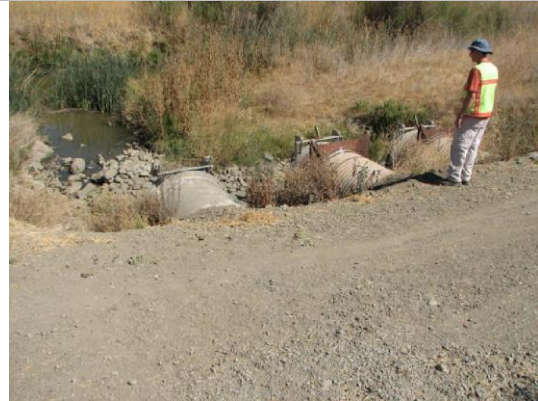
Photo 1 of 3 : UCIP_SP_2019_45295_22794.jpg

Waterside overview- far right 42-inch pipe.

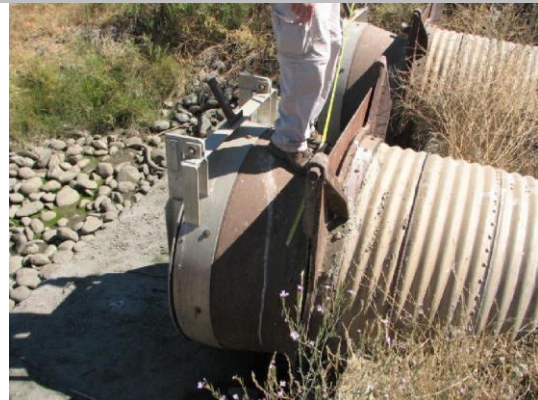
Photo 2 of 3 : UCIP_SP_2019_45295_22793.jpg

Waterside view- 42-inch steel pipe and flap gate (right).

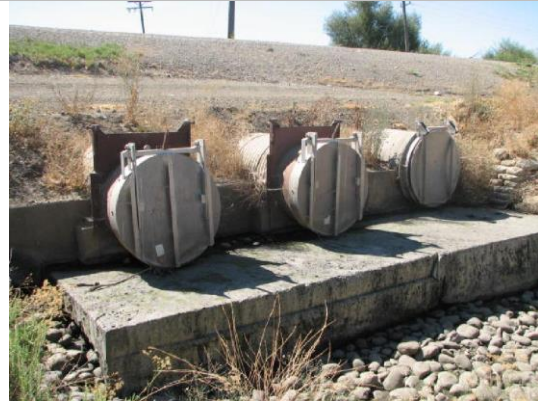
Photo 3 of 3 : UCIP_SP_2019_45295_22796.jpg

Waterside overview- outlet structure.

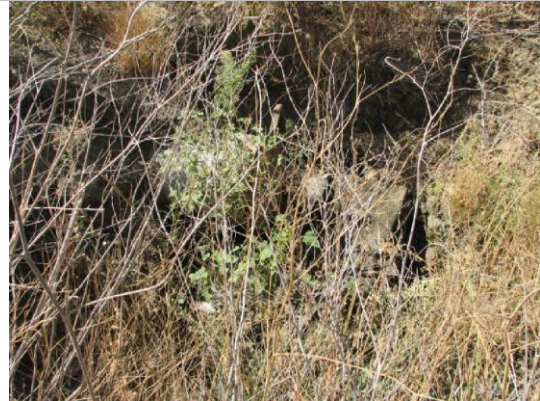
Photo 1 of 3 : UCIP_SP_2019_45298_22805.jpg

Waterside overview- pipe and flap gate with dense vegetation.

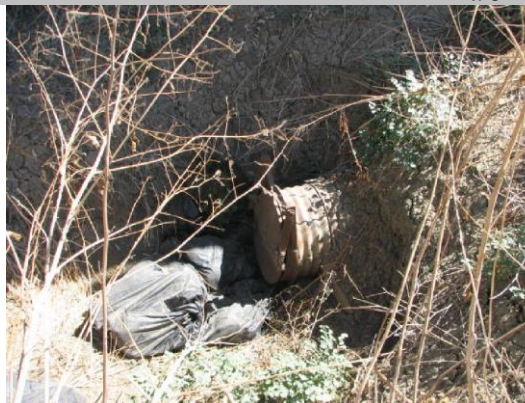
Photo 1 of 3 : UCIP_SP_2019_45285_22809.jpg

Waterside view- pipe and flap gate.

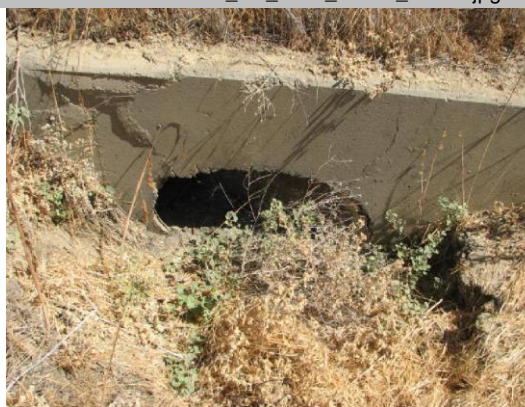
Photo 2 of 3 : UCIP_SP_2019_45285_22811.jpg

Landside view- pipe and headwall.

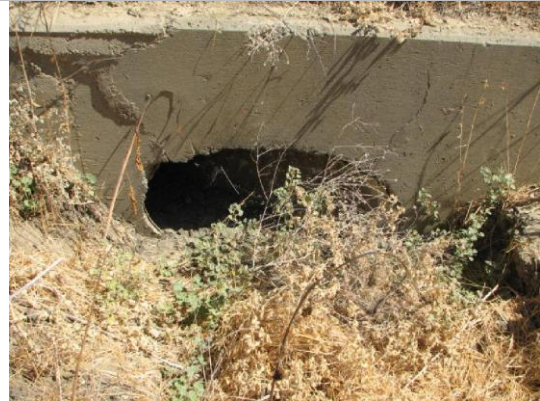
Photo 3 of 3 : UCIP_SP_2019_45285_22810.jpg

Landside view- soil and debris on mouth of the inlet pipe.

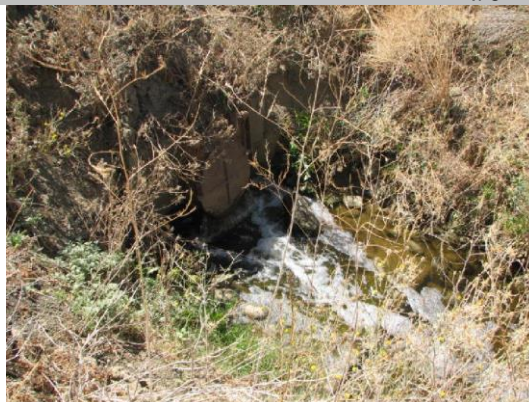
Photo 3 of 3 : UCIP_SP_2019_45301_22846.jpg

Waterside view- pipe and flap gate. Water was running in the pipe during the survey.

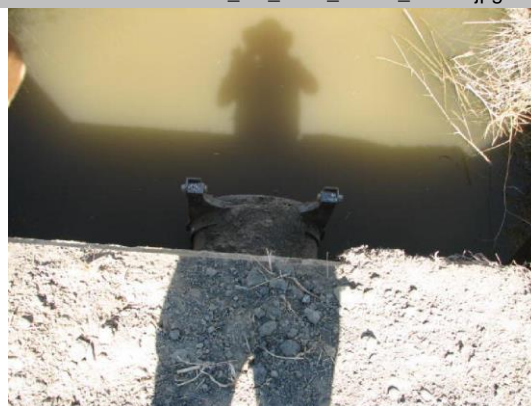
Photo 2 of 3 : UCIP_SP_2019_45302_22848.jpg

Waterside view-pipe and flap gate

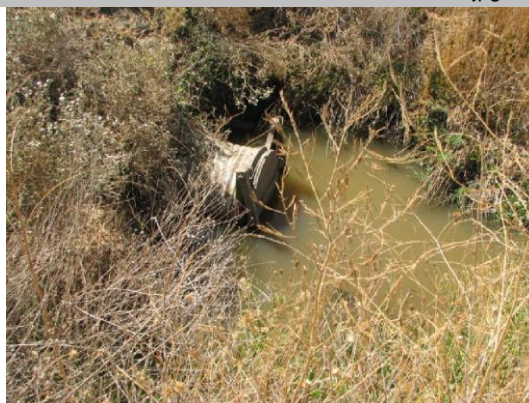
Photo 2 of 3 : UCIP_SP_2019_45306_22872.jpg

Waterside view- pipe and flap gate.

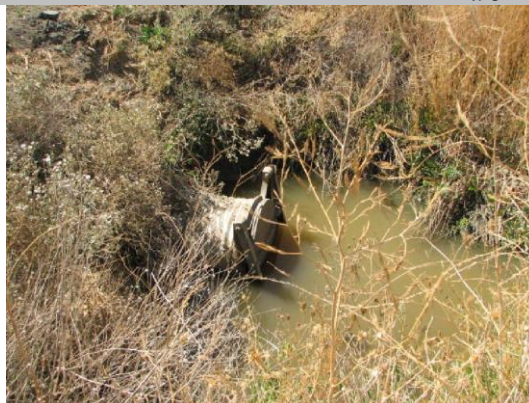
Photo 3 of 3 : UCIP_SP_2019_45306_22876.jpg

Waterside view- pipe and flap gate.

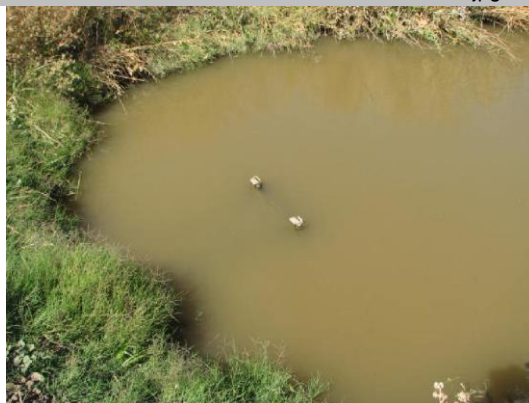
Photo 2 of 3 : UCIP_SP_2019_45307_22868.jpg

Waterside view- outlet structure under the water.

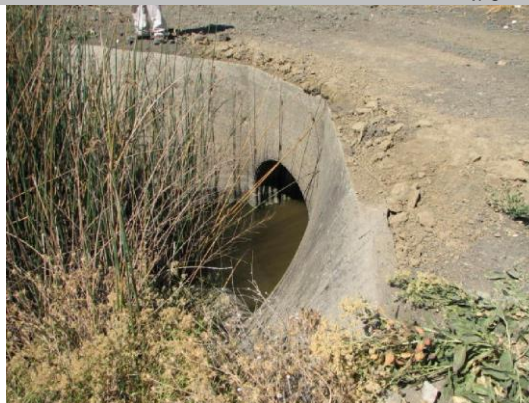
Photo 1 of 2 : UCIP_SP_2019_45309_22878.jpg

Landside view- Wing wall and pipe

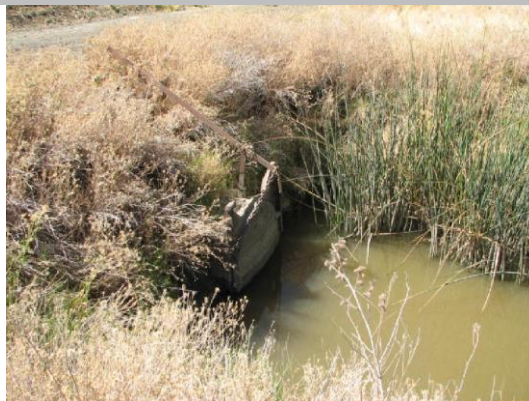
Photo 2 of 2 : UCIP_SP_2019_45309_22877.jpg

Waterside view- pipe and flap gate
